## Historic Churchyards Project News Article 16.01.2012.

### Natural damage to stone

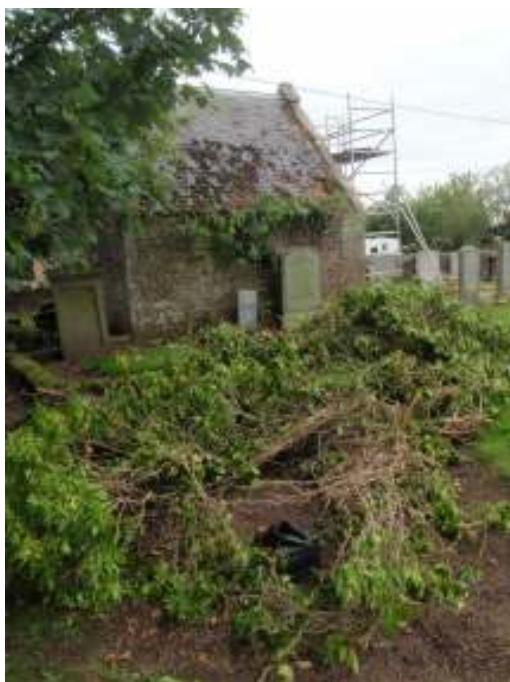
Simprim Mausoleum

In the depths of winter, extreme temperature variations, wind and rain, sometimes combining with the detrimental effects of tree and ivy growth, can cause damage to carved stone monuments and masonry in historic churchyards. Wind can cause damage even in summer and in June 2011 ivy was blown off the Simprim mausoleum in Coupar Angus Abbey churchyard, taking with it some of the slates and the skewes (or sloping stone copings on gable walls). Fortunately repair and restoration work to the B-listed building is set to begin.

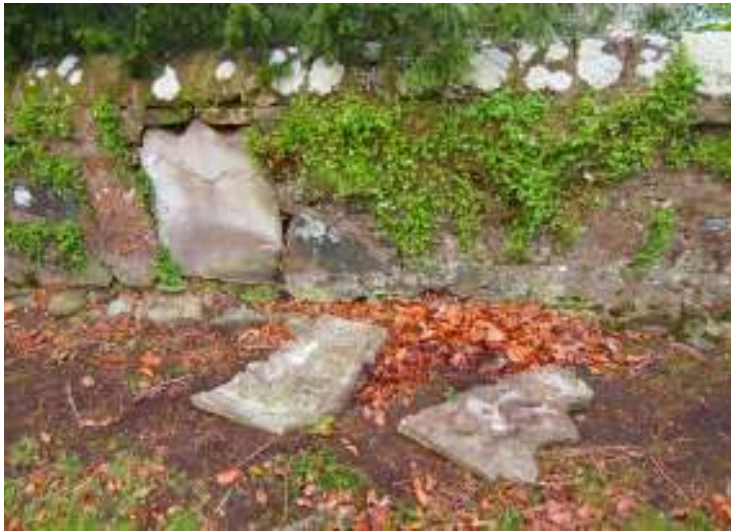
Caputh 18<sup>th</sup> C stone

Perth and Kinross Council has a superb selection of 18th century stones which are mostly sandstone of varying softness. Buildings and walls also tend to be built in sandstone and where it is soft, open-grained or laminar (or layered) it is liable to erosion, of being worn away by the weather. In the old part of Caputh graveyard the carved surface of an 18th century stone of heritage interest has shorn off. Evidence of delamination, where layers of stone separates and may split off, can be seen in many historic churchyards.

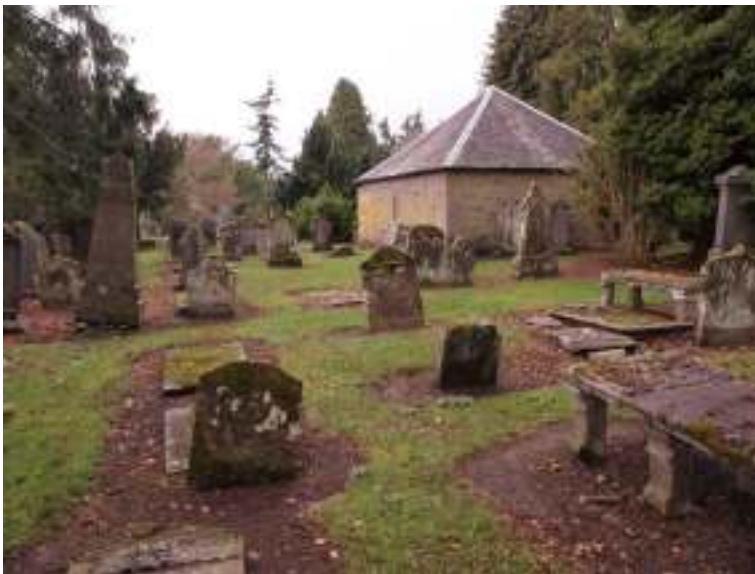
Large trees at Caputh

Also in Caputh, trees have been blown down both in May and in December 2011 and the stone boundary walls have been damaged. It was fortunate that the Delvine McKenzie mausoleum, which is believed to be a part of the former Medieval church (although much altered), was not flattened. Majestic redwoods, cypresses and other tall trees, which however attractive, are generally inappropriate to a small historic graveyard, can represent a threat to historic buildings and monuments. In Cargill two mature beech trees blew down before Christmas and toppled a classical column and an obelisk.

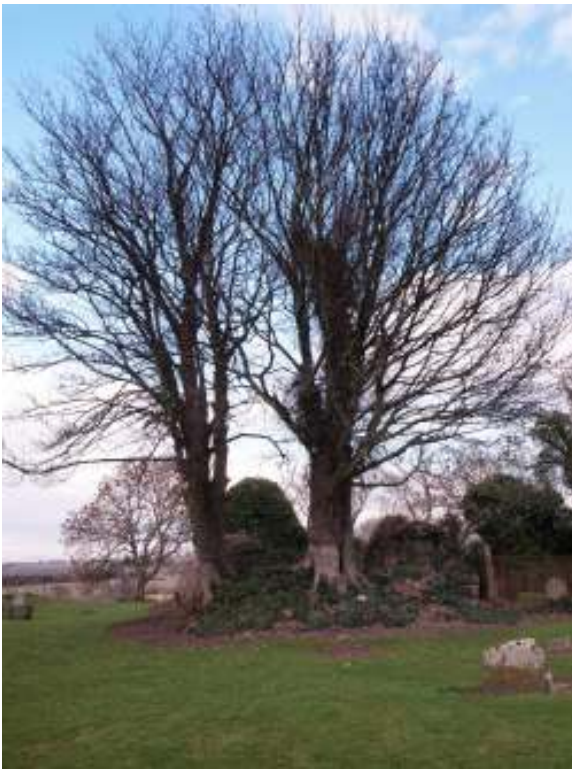
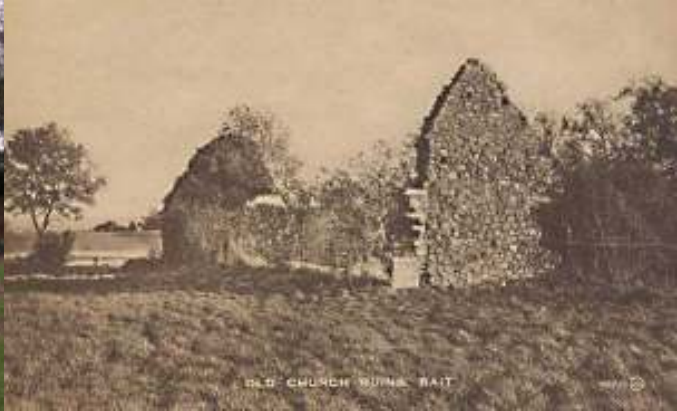
Rait today

At Rait there are two large sycamores which have self seeded (the 1911 postcard and the current photo show the difference in 100 years all due to unchecked tree growth). They will be felled with the utmost care in January 2012. Ivy causes untold problems when left unchecked. Kinfauns Old parish church was partially cleared of ivy in September 2011. The ivy growth had reached tree trunk proportions and had to be carefully cut and treated. Interesting stone features, but equally, much damage was revealed and the medieval masonry will require to be restored. It is planned to continue ivy clearance work with volunteers in February 2012.
